## Concrete Scaling

### Determining the cause of concrete scaling

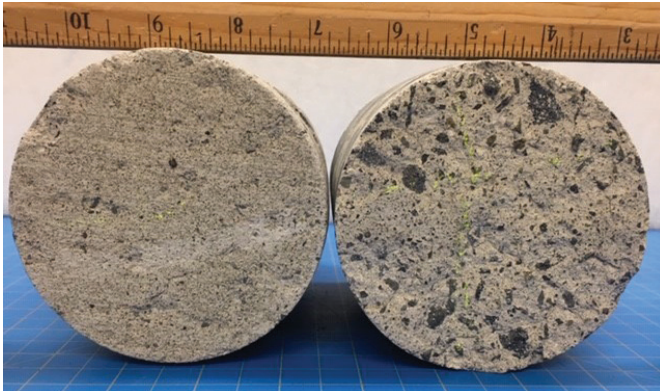
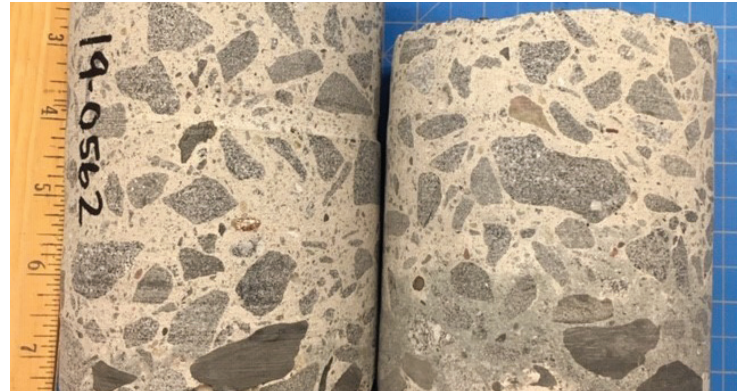
**Figure 1**  
Cores taken from scaled areas.

A common reason for a concrete petrographic examination is to determine the cause of scaling. The American Concrete Institute (ACI) defines scaling as “local flaking or peeling away of the near-surface portion of hardened concrete or mortar.”<sup>1</sup> In this example, two cores were taken from residential flatwork (Figure 1). The photograph on the left shows the top surface of the cores and the image on the right shows the cores in cross section.

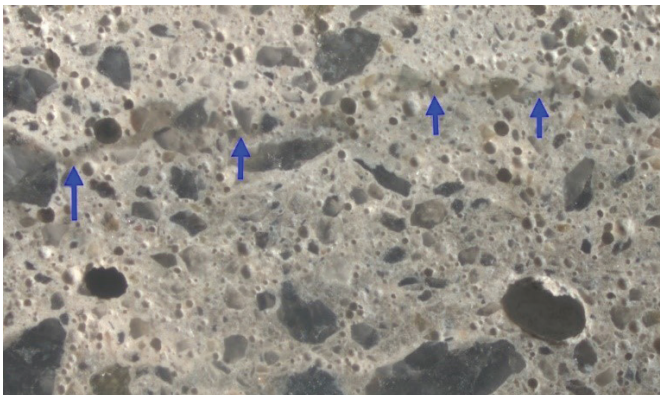
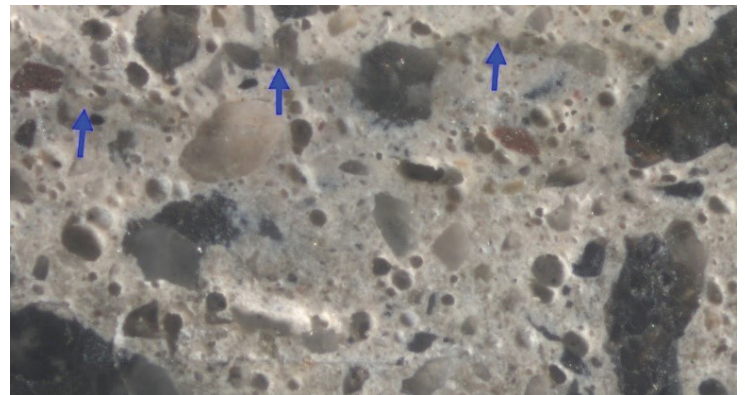
**Figure 2**  
Cross section of each core as viewed under the stereomicroscope. Notice the light-colored paste near the surface and the dark line (blue arrows).

The light-colored paste near the surface and dark line just below it (blue arrows) are evidence that the concrete was not adequately cured (Figure 2). Moist curing or using a membrane curing compound keeps the surface moist so the cement can continue to hydrate and achieve an adequate compressive strength. If the surface dries out, water is not available to react with the cement and hydration stops. This can make the surface paste weak and not able to withstand freeze-thaw cycles even when the air-void system is good. This concrete was determined to have an adequate air-void system. Inadequate curing resulting in a weaker surface paste that was susceptible to freeze-thaw distress, was determined to be the cause of scaling.
