Sealing of expansion joints in a water irrigation channel

Cova da Beira irrigation channel

MasterSeal NP 474, joint sealing in an irrigation channel

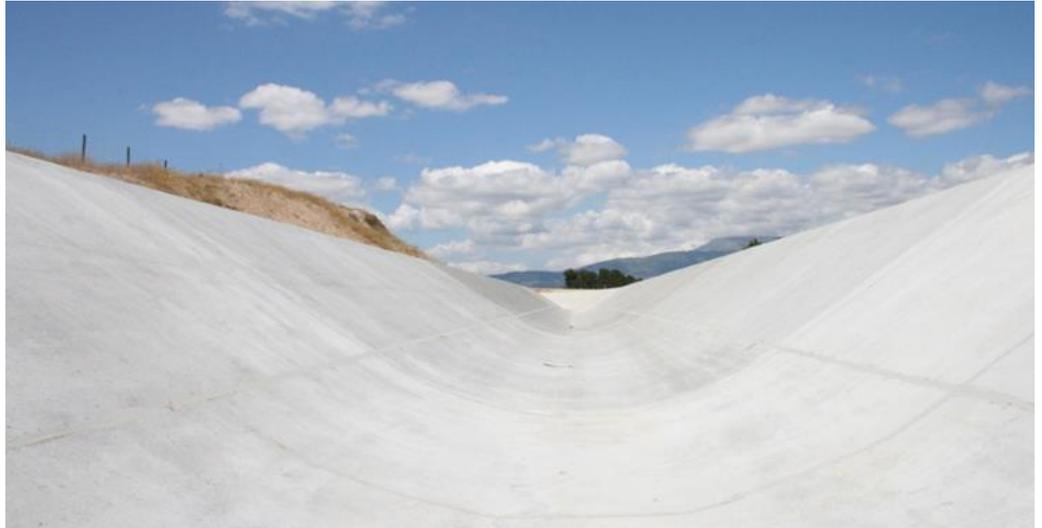
Our project reference in Cova da Beira (Portugal)

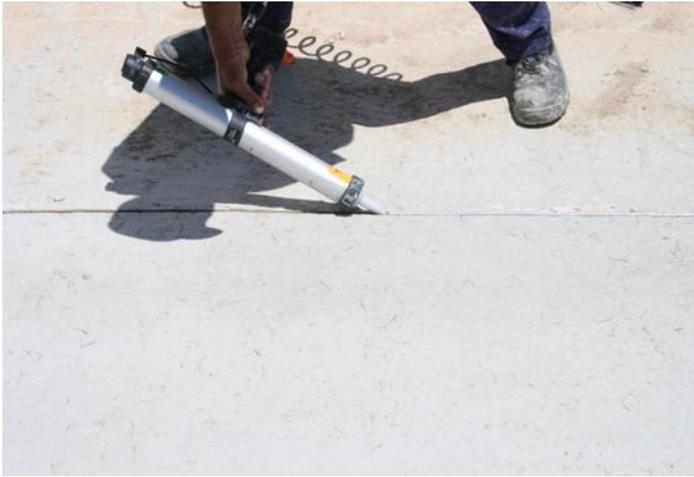
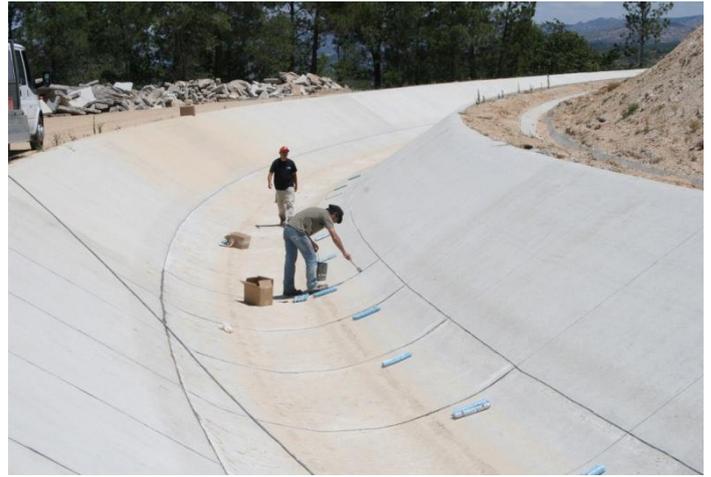
Joint sealing in Cova da Beira (Portugal)

MasterSeal NP 474 is a single-component, medium-high modulus polyurethane sealant. The product can be supplied in 310 ml cartridges or 600 ml sausages in different colours.

- Approx. 28,000 sausages of MasterSeal NP 474 were applied.
- The channel was designed with a trapezoidal cross-section with a width of 2 m and a height of 2.30 m.
