Waterproofing and repair of a dam

Hervás - Cáceres (Spain)

PRESA DE HORCAJO (CÁCERES)

Upstream waterproofing and repair

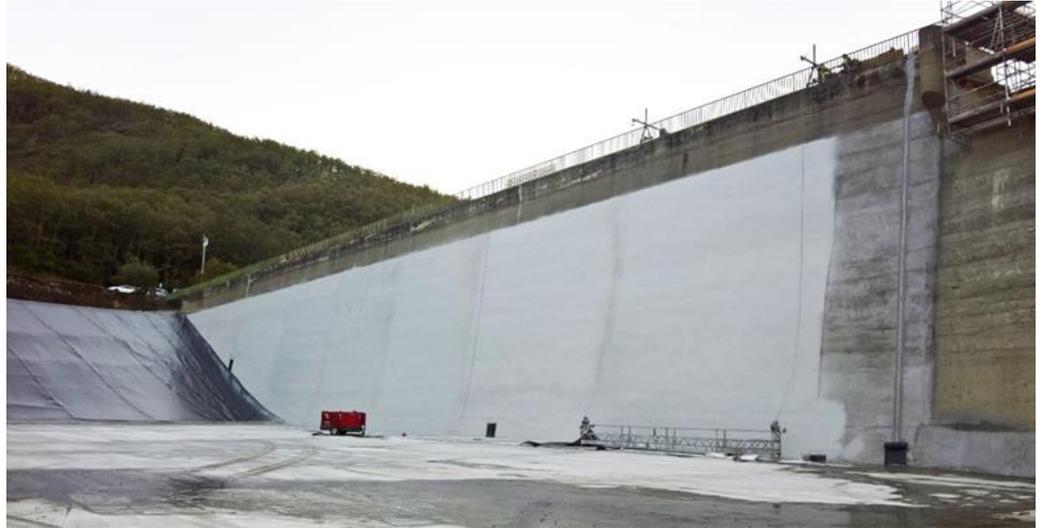
Concrete refurbishment on the upstream face of the dam. Presa de Horcajo in Hervás-Cáceres (Spain)

The dam was constructed with concrete poured in different stages. For this reason, several vertical movement joints were created. The surface of the concrete is porous and highly absorbent, allowing water infiltration.

The geographical situation of the dam also generates concrete damages due to freeze-thaw.

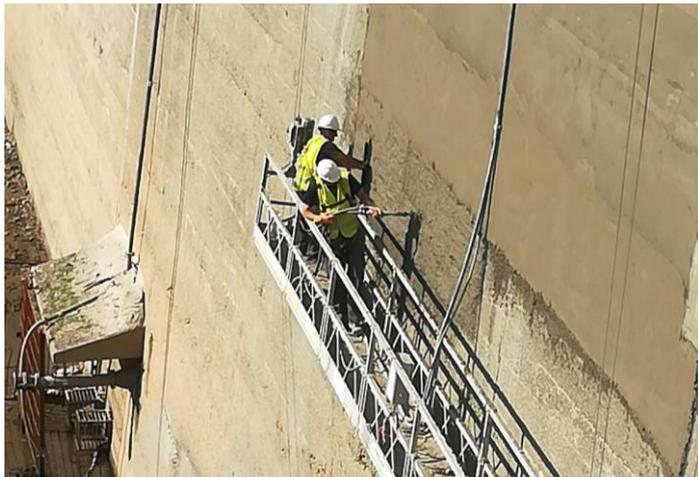
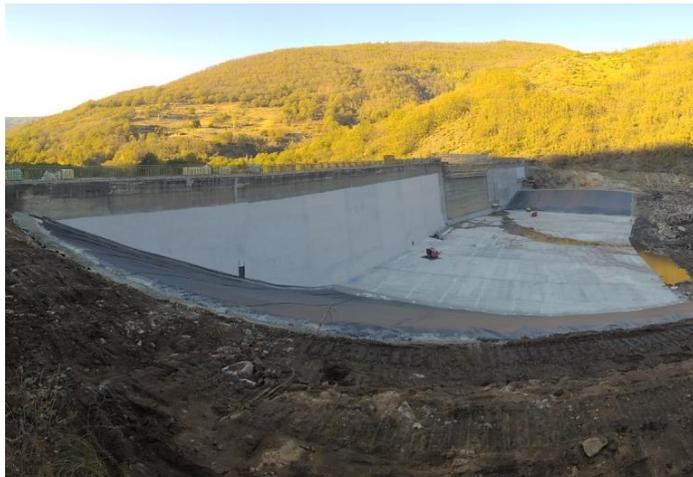
Application of MasterEmaco S 5300 medium modulus repair mortar and finishing with MasterSeal 6100 FX cementitious waterproofing membrane.

The first step was to refurbish the surface using MasterEmaco S 5300 medium modulus (15 GPa) repair mortar, which is also sulphate resistant. The average thickness was 2.5-3 cm.

All vertical joints were sealed MasterSeal 930 using elastic tape, bonded with MasterSeal 933 adhesive. The joints were sealed using MasterSeal NP 474 single-component polyurethane sealant before this system was applied.

Finally, MasterSeal 6100 FX elastic waterproofing membrane was applied. The features of MasterSeal 6100 FX include low consumption, high crack bridging capacity and UV resistance.
