Repair and waterproofing of a dam gallery

Iznájar – Córdoba (Spain)

DAM IZNÁJAR

Concrete repair and waterproofing of dam gallery

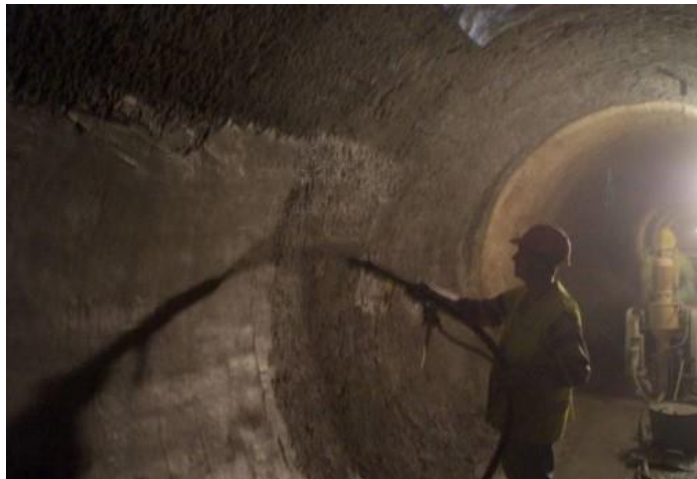
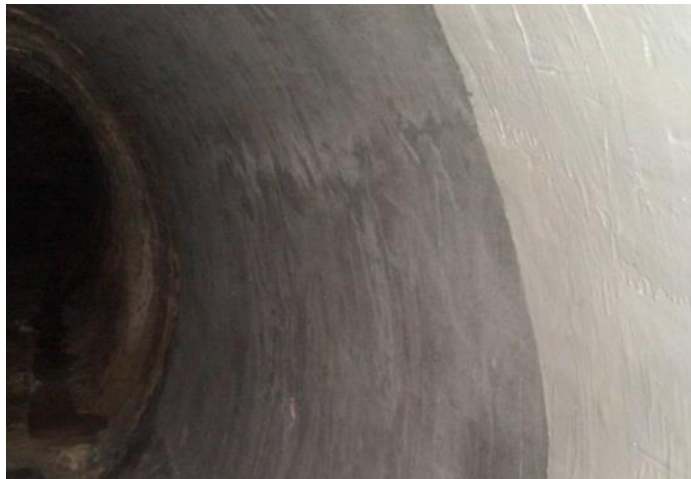
Concrete repair and protective waterproofing work on the gallery

For the repair of damaged concrete MasterEmaco S 5400 was used. Intensive surface preparation was required for the application of the repair mortar, the service was cleaned, and damaged concrete was removed by manual brushing and high-pressure water jetting.

MasterEmaco S 5400 was applied by spraying. Following application, the mortar was troweled to obtain a smooth surface.

After the hardening of the mortar, the two-component water based epoxy coating MasterSeal M338 was applied.
