Mølleåværket Treatment Plant.
Renovation of the digester.

Mølleåværket Treatment Plant Renovation of the digester

Digester renovated with MasterSeal 7000 CR, (Kongens Lyngby - Denmark)

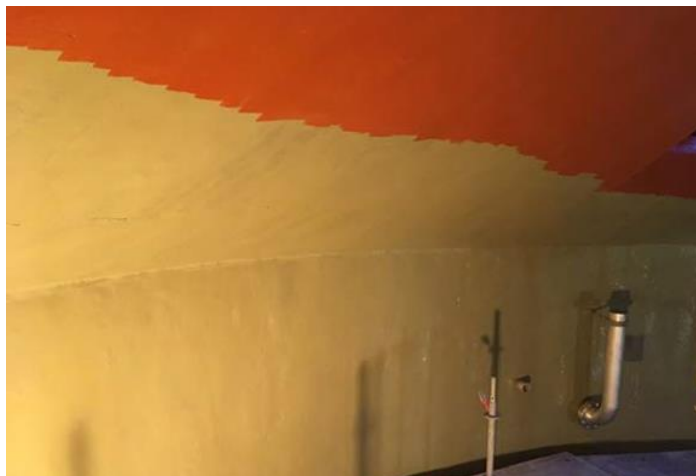
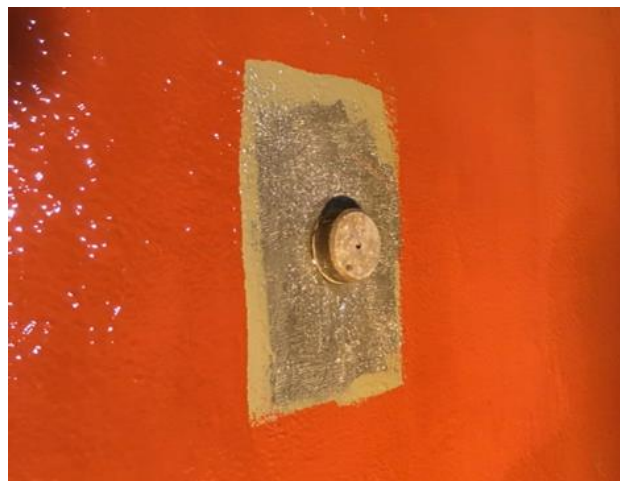
MasterSeal M 790 is applied in two coats - first in gray and then in red

First, the concrete surface was pretreated by sandblasting and then reprofiled with the sulfate resistant repair mortar, MasterEmaco S 5400.

To treat the surface, the consultant, in close cooperation with the BASF specialist, opted to use the unique MasterSeal 7000 CR which comprises the products MasterSeal P 770 and MasterSeal M 790.

The surface was primed with MasterSeal P 770, and after hardening of the primer, finally, the protective membrane MasterSeal M 790 was applied twice in gray and red coats, in order to reliably ensure complete coverage of the surface.
