Mølleåværket Treatment Plant.
Renovation of the digester.

Kongens Lyngby (Denmark)

2018

Mølleåværket Treatment Plant Renovation of the digester

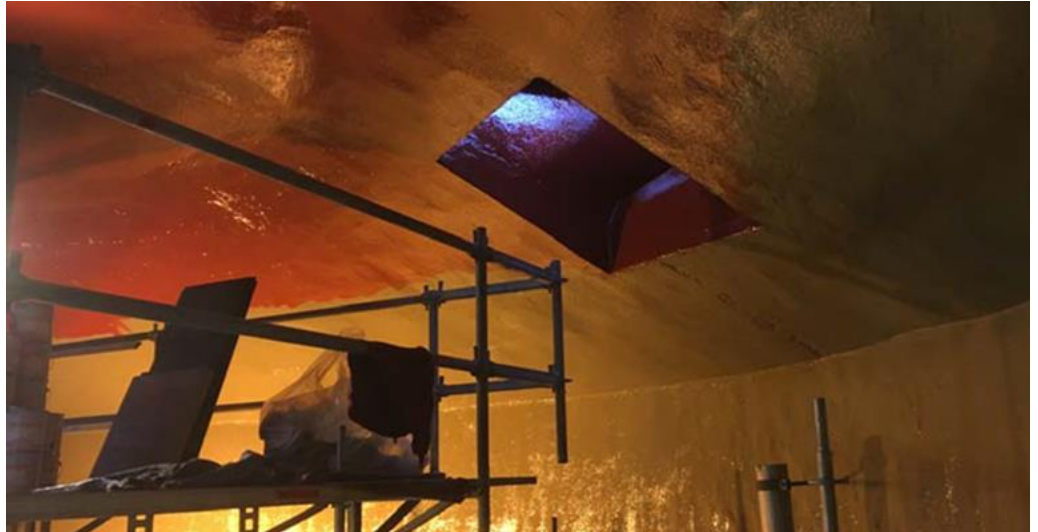
Digester renovated with MasterSeal 7000 CR, (Kongens Lyngby - Denmark)

In 2018, a digester at the plant needed refurbishment. The concrete surface had become degraded and needed to be fully repaired and protected with surface treatment to ensure a longer lifetime of the structure.

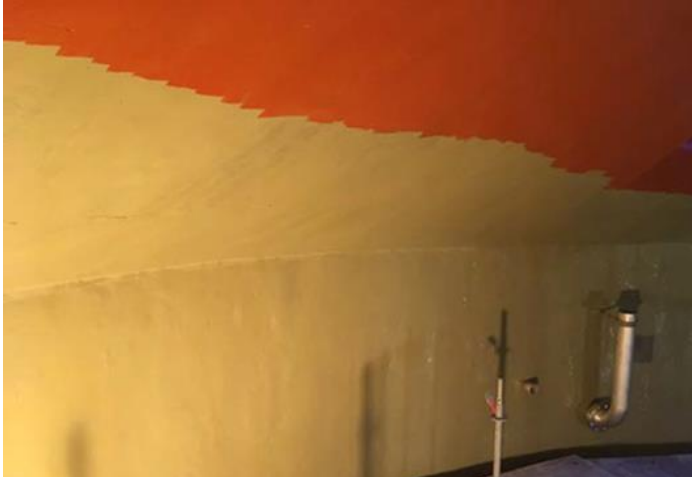
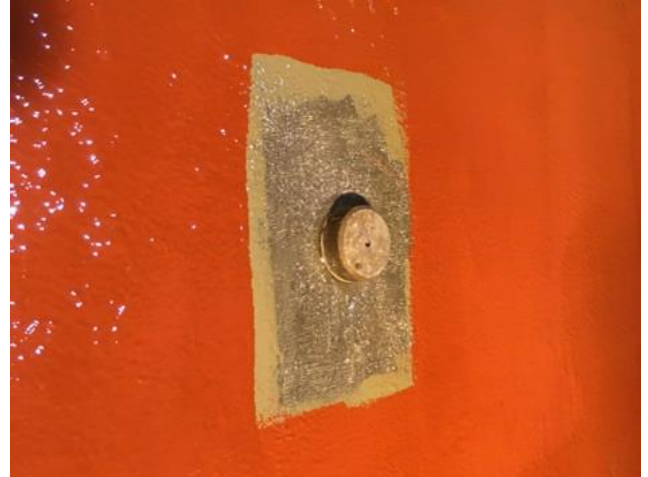
MasterSeal M 790 is applied in two coats - first in gray and then in red

The surface was primed with MasterSeal P 770, and after hardening of the primer, finally, the protective membrane MasterSeal M 790 was applied twice in gray and red coats, in order to reliably ensure complete coverage of the surface.
