Secondary clarifier in Września

Września (Poland)

Waterproofing in high chemical demanding environment

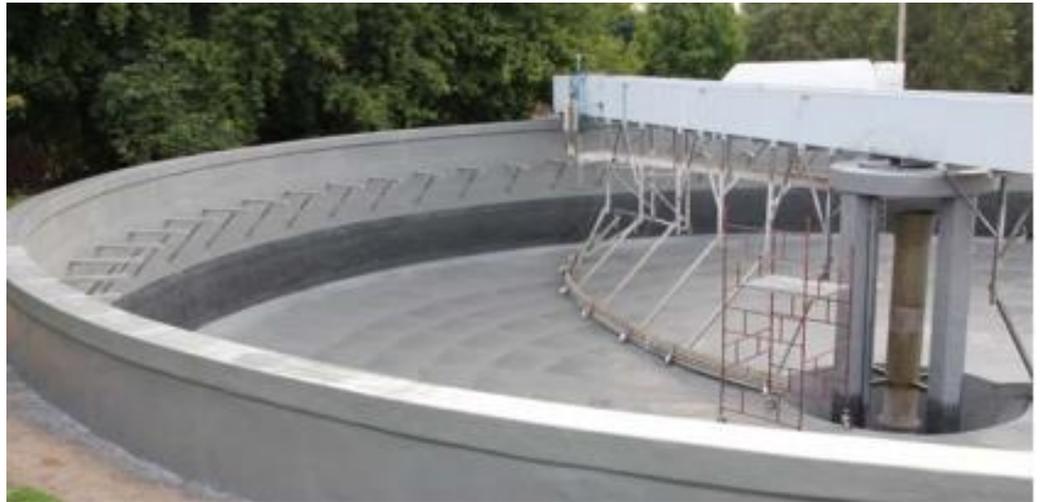
The waste water treatment plant of the area, built by Września Commune was given to exploitation in 1997 and required renovation works due to the severe damages observed in existing protective coatings under the influence of chemical attack.

Secondary clarifiers are exposed to high degree of humidity concrete reinforcement corrosion and eventually release of hydrogen sulphide (H₂S) especially in anaerobic areas.

The damages to the protective coatings are normally related to the highly demanding chemical environment but also mechanical as most of what settles to the bottom is then sent by mechanically driven scrapers towards a hopper thus creating friction and abrasion.

The proposed solution was to apply a hot spray polyurea membrane: MasterSeal M 689.

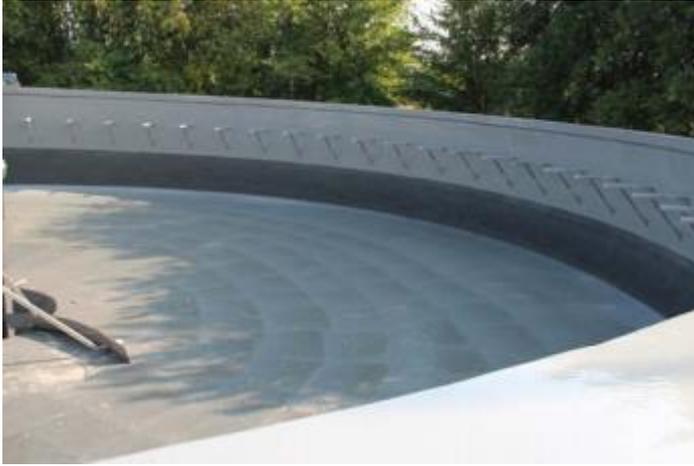
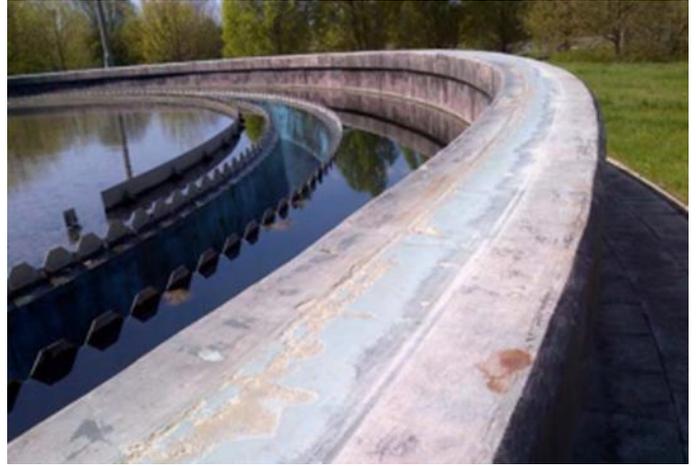
The membrane was applied on a properly treated and cleaned concrete surface after the application of MasterTop P 617 primer used to ensure adhesion and to seal concrete pores.

MasterSeal M 689 was applied by means of a suitable two-component heated, high pressure, proportioning spray equipment. The application was done by an expert company that could solve all technical requirements at the jobsite.
