Repair and protection of a buffer tank at Vion meat processing factory

Repair and protection of a buffer tank

Our reference in Boxtel, Netherlands: repair of a buffer tank

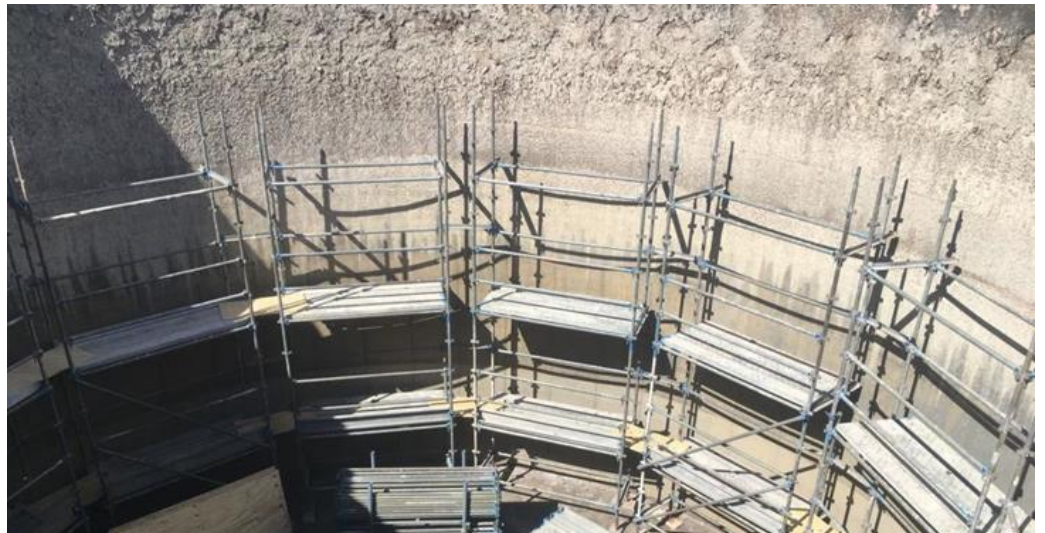
The animal waste in the buffer tank was highly aggressive and had therefore impacted the concrete (so that the covering was only 2 cm in thickness). This meant that the acid in the waste could attack the reinforcement.

The concrete in the tank was seriously damaged and therefore urgently in need of repair.

The concrete was repaired with MasterEmaco S 480 structural concrete repair mortar, class R4. This was subsequently applied using the wet spray method until a layer of 4–5 cm as protective cover on the rebars was restored.

MasterSeal 7000 CR was applied as a crack-bridging protective coat on the complete concrete surface of the tank thanks to its unique chemical resistance properties.

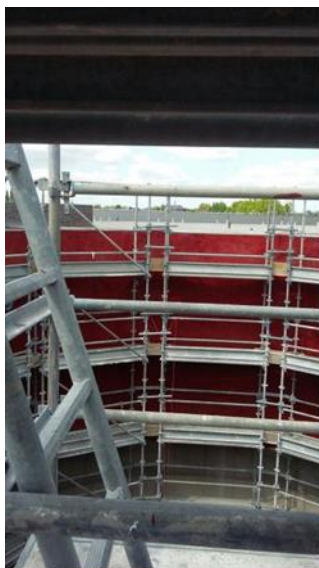
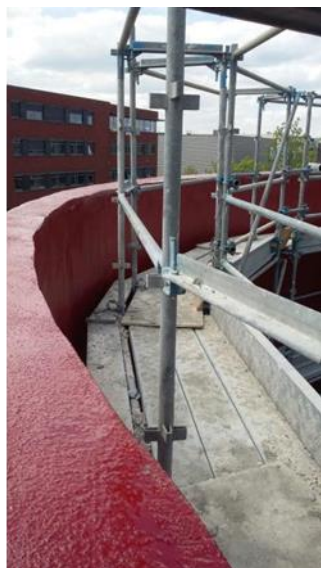
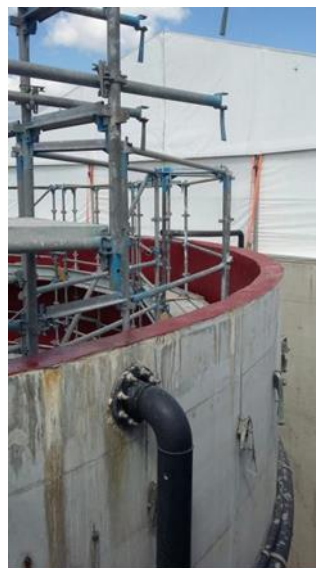
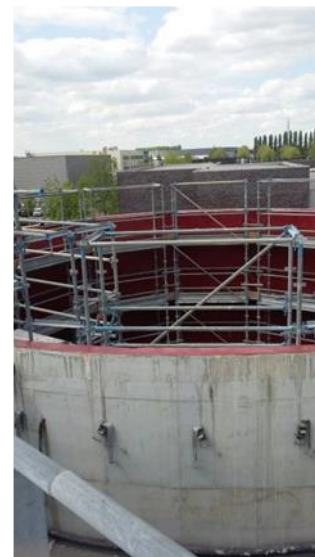
Our reference project at Vion, Netherlands: repair of a buffer tank.
