Repair and protection of a buffer tank at Vion meat processing factory

Boxtel (Netherlands)

### Repair and protection of a buffer tank

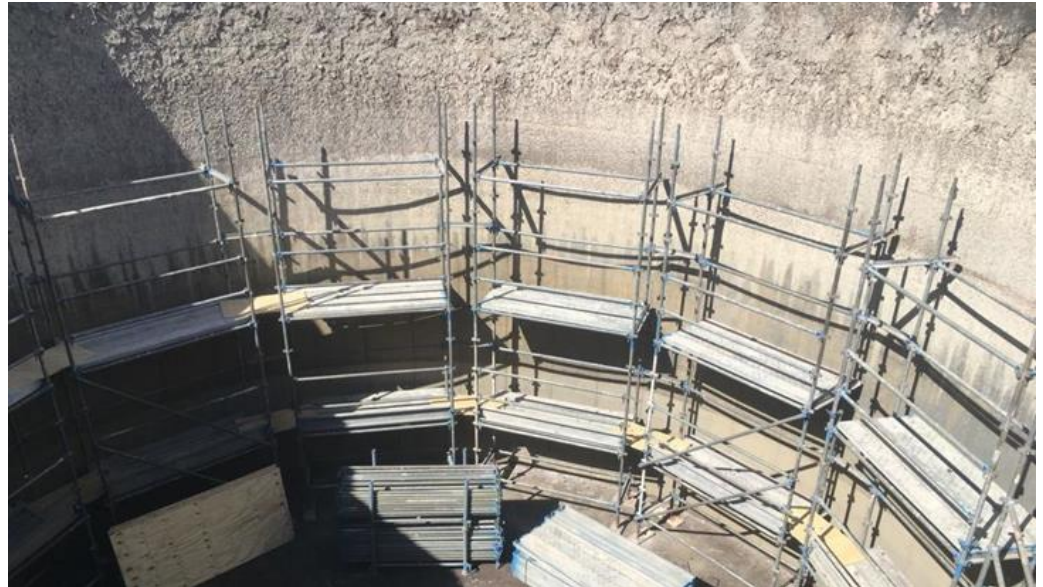
Our reference in Boxtel, Netherlands: repair of a buffer tank

The animal waste in the buffer tank was highly aggressive and had therefore impacted the concrete (so that the covering was only 2 cm in thickness). This meant that the acid in the waste could attack the reinforcement.

The concrete in the tank was seriously damaged and therefore urgently in need of repair.

The concrete was repaired with MasterEmaco S 480 structural concrete repair mortar, class R4. This was subsequently applied using the wet spray method until a layer of 4–5 cm as protective cover on the rebars was restored.

MasterSeal 7000 CR was applied as a crack-bridging protective coat on the complete concrete surface of the tank thanks to its unique chemical resistance properties.

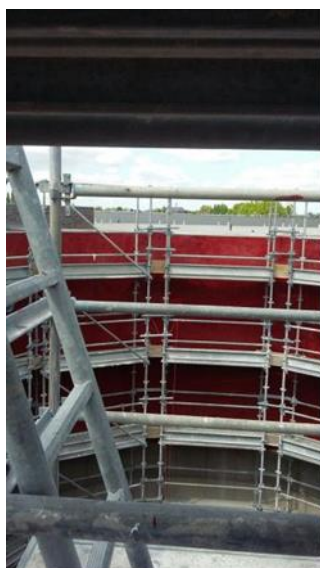
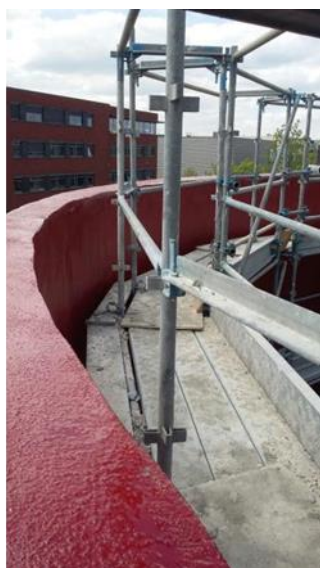
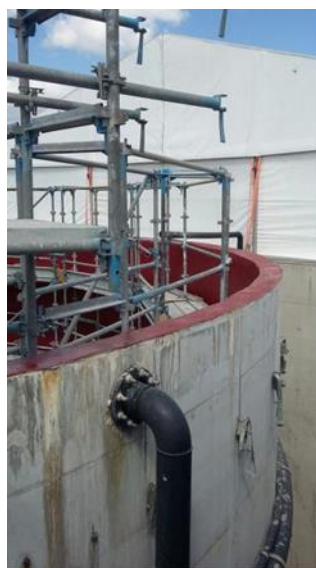
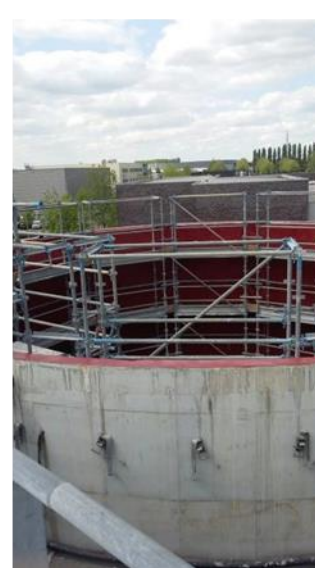
Our reference project at Vion, Netherlands: repair of a buffer tank.
