**Project:**  
Water Treatment Works

**Location:**  
Dorset

## Water Treatment Works, Dorset Refurbishment of Filter Beds

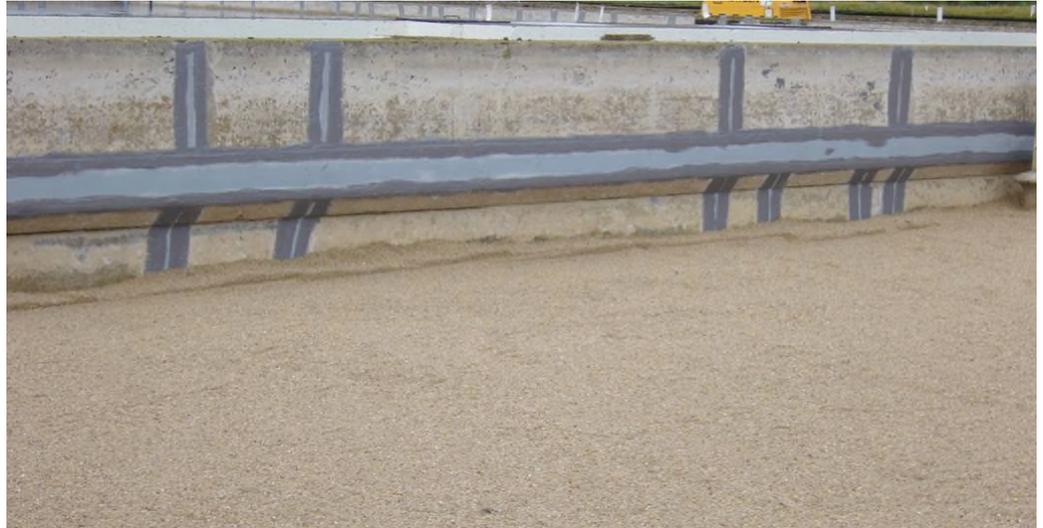
Our reference in, Dorset (United Kingdom): Water Treatment Works

The filter beds at the facility required refurbishment and re-commissioning within a short timescale to ensure plant efficiencies within the water treatment plant were maintained.

After removal of the filter sand, concrete repairs were required using a rapid-setting mortar to enable the concrete to be returned to service quickly. A flexible, elastomeric membrane and adhesive system was required to over-band existing failed joints. Both materials were to be approved under Regulation 31, for use with potable water.

MasterEmaco S 420 was specified to repair internal and external concrete elements on the walls and parapets, and MasterSeal 930 membrane and MasterSeal 933 adhesive were chosen to over-bandage existing failing joints and cracks in the tanks. MasterSeal NP 474 was selected to seal external joints and internal joints above the water line, while MasterProtect 330 EL provided flexible anti-carbonation coating in the required colour for the external concrete walls for long-term protection.
