Project:
New Water Tower

Location:
Feluy, Belgium

Feluy Water Tower

New concrete water tower

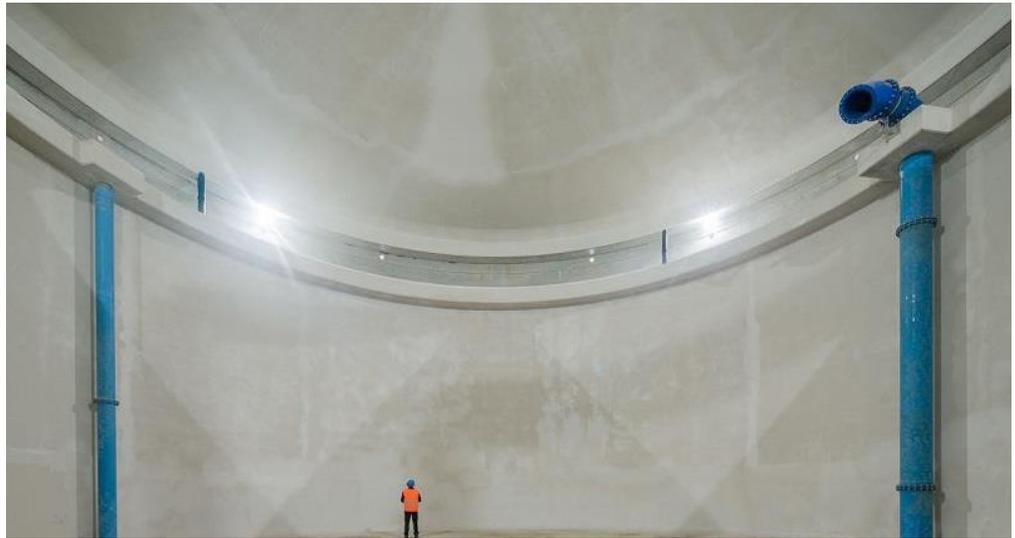
Our reference project in Feluy, Belgium: new water tower (Designed by IDEA)

To satisfy such high demand, IDEA undertook the construction of a new water tower with a capacity of 2,500 cubic meters of drinking water. It was built opposite the existing water tower, which is made of metal.

The entire building is made completely of concrete, i.e. including the lowest level, the intermediate floors and the walls. These had to be coated to protect the concrete against carbonation among other things.

The water tower was constructed seamlessly and without joints, using climbing formwork. This meant, however, that the composition of the concrete had to meet certain requirements.

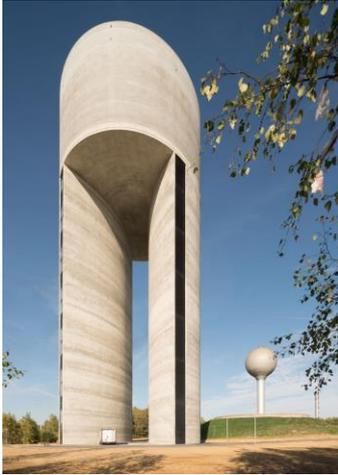
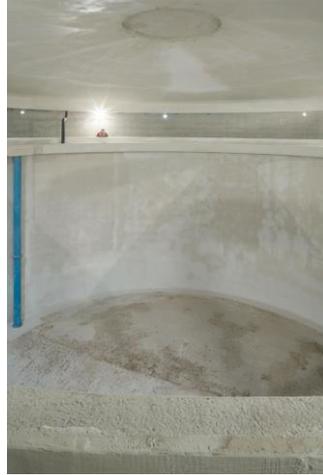
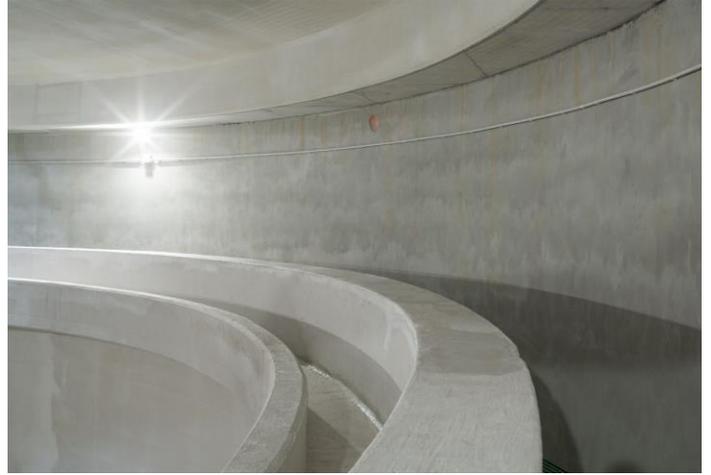
Our reference project in Feluy, Belgium: new water tower (Designed by IDEA)

- Water tower, built entirely in concrete, approx. 56 meters high
- MasterSeal 550 used as protective and waterproofing membrane.
- BASF auxiliary materials from MasterGlenium Sky and MasterSet gamma.
