**Project:**  
Secondary clarifier in Września

## Secondary clarifier in Września

### Waterproofing in high chemical demanding environment

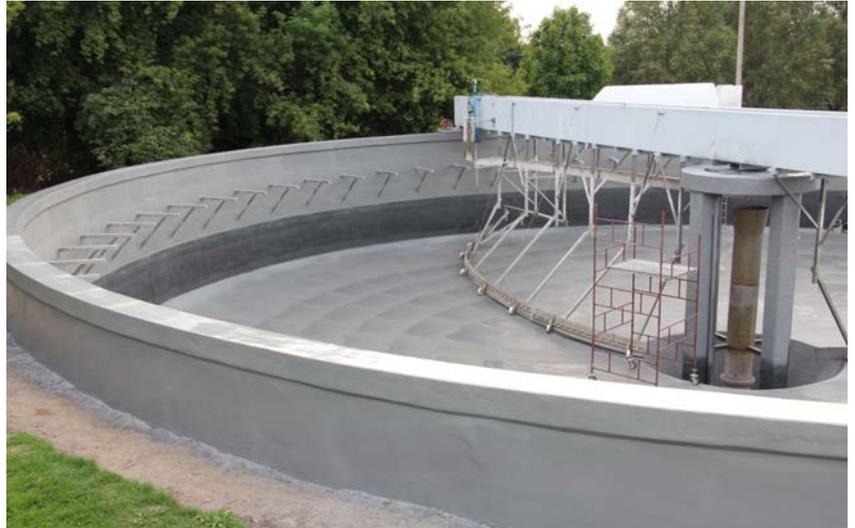
The waste water treatment plant of the area, built by Września Commune was given to exploitation in 1997 and required renovation works due to the severe damages observed in existing protective coatings under the influence of chemical attack.

Secondary clarifiers are exposed to high degree of humidity concrete reinforcement corrosion and eventually release of hydrogen sulphide (H<sub>2</sub>S) especially in anaerobic areas.

The damages to the protective coatings are normally related to the highly demanding chemical environment but also mechanical as most of what settles to the bottom is then sent by mechanically driven scrapers towards a hopper thus creating friction and abrasion.
