Sealing of expansion joints in a water irrigation channel

Covilhã (Portugal)

MasterSeal NP 474

Our project reference in Cova da Beira (Portugal)

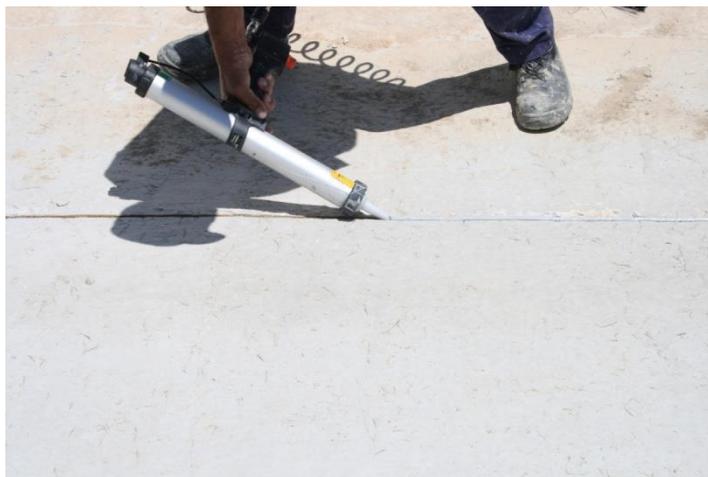
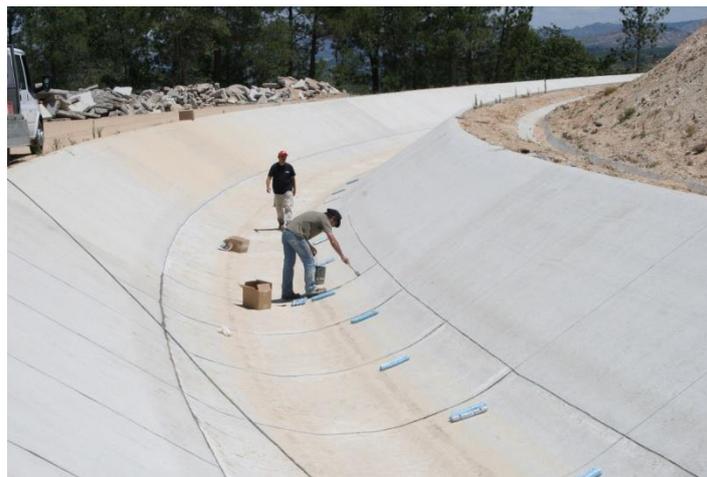
Cova da Beira irrigation channel

MasterSeal NP 474, joint sealing in an irrigation channel

The structure must therefore be designed to accommodate these movements. For this purpose, joints are included in the structure. These must be sealed with a product that can remain elastic in the long term and is suitable for constant immersion in water.

MasterSeal NP 474 is a single-component, medium-high modulus polyurethane sealant. The product can be supplied in 310 ml cartridges or 600 ml sausages in different colours.

- Approx. 28,000 sausages of MasterSeal NP 474 were applied.
- The channel was designed with a trapezoidal cross-section with a width of 2 m and a height of 2.30 m.
