Project:
ETAP EL ATABAL

Location:
MÁLAGA

Market sector:
Water Management Industry

ETAP EL ATABAL – Primary sedimentation tank Repair, reinforcement, protection and waterproofing

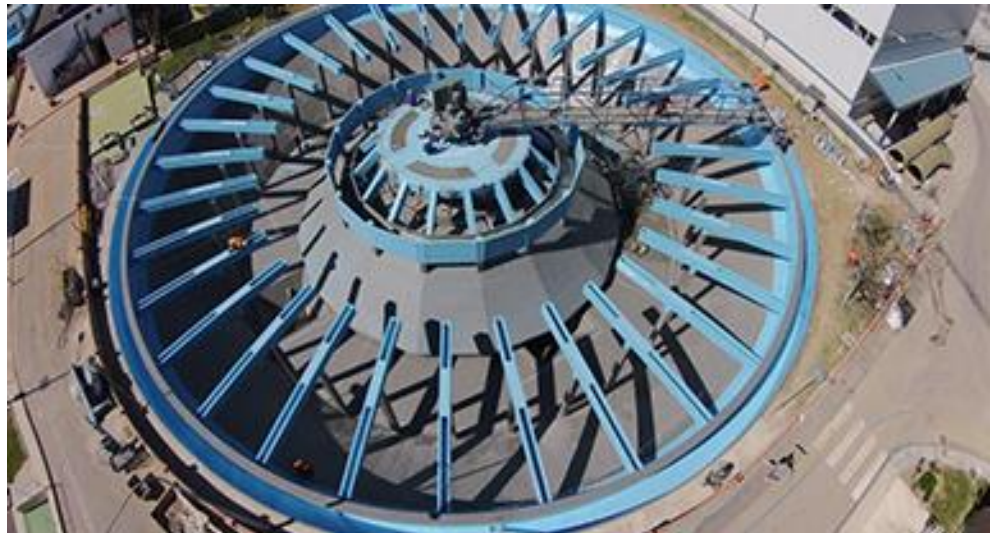
Aerial view of the primary sedimentation tank at the water treatment works ETAP El Atabal, (Málaga – Spain)

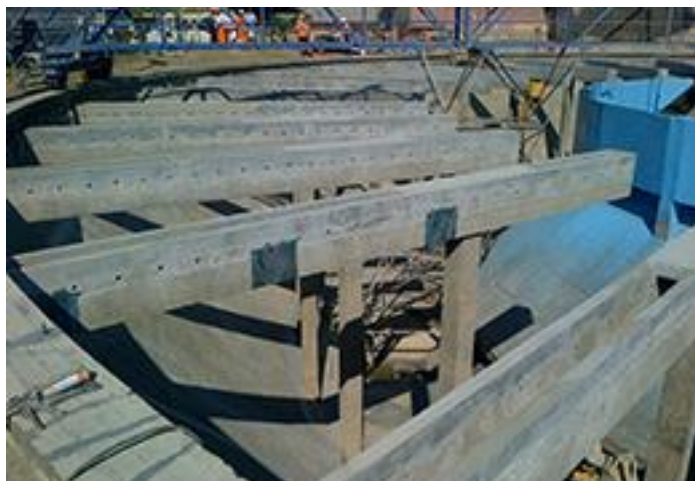
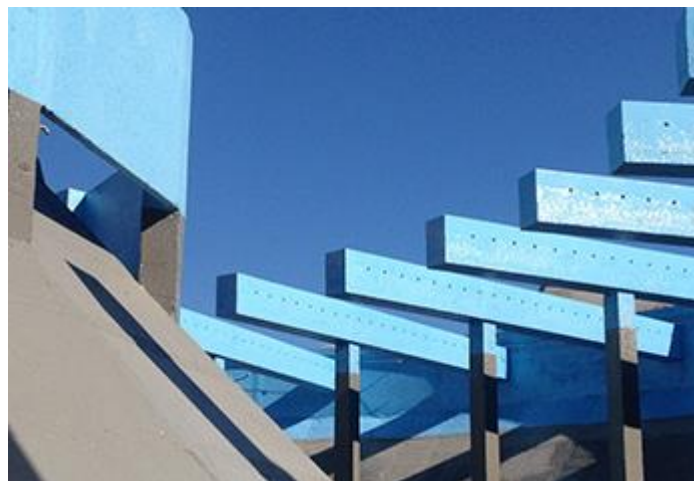
Full refurbishment including concrete repair, reinforcement, and protective waterproofing in accordance with EN 1504

- Structural injection of concrete using low-viscosity epoxy resin MasterInject 1360.
- Structural concrete repair using MasterEmaco S 5450 PG flowable repair mortar and MasterEmaco S 5300 thixotropic repair mortar MasterEmaco S 5300.
- Reinforcement using carbon fiber system to replace lost rebar section.
- Application of MasterProtect 8000 CI corrosion inhibitor.
- Application of MasterSeal M 808 chemical-resistant waterproofing membranes with high crack bridging properties and MasterSeal M 391.
