Repair and waterproofing of a dam gallery

Iznájar – Córdoba (Spain)

## Concrete repair and waterproofing of dam gallery

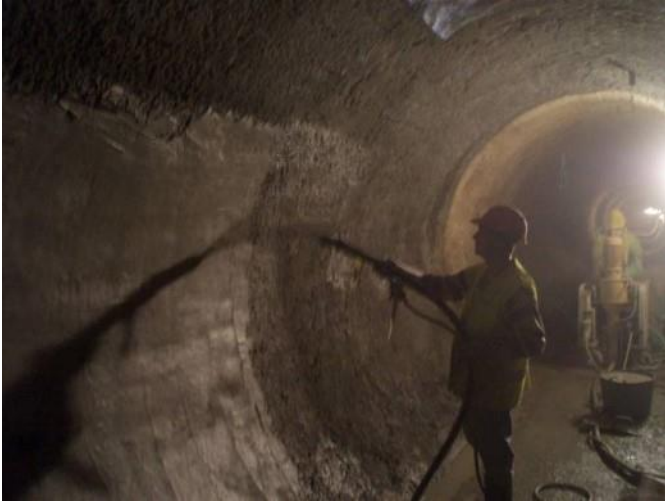
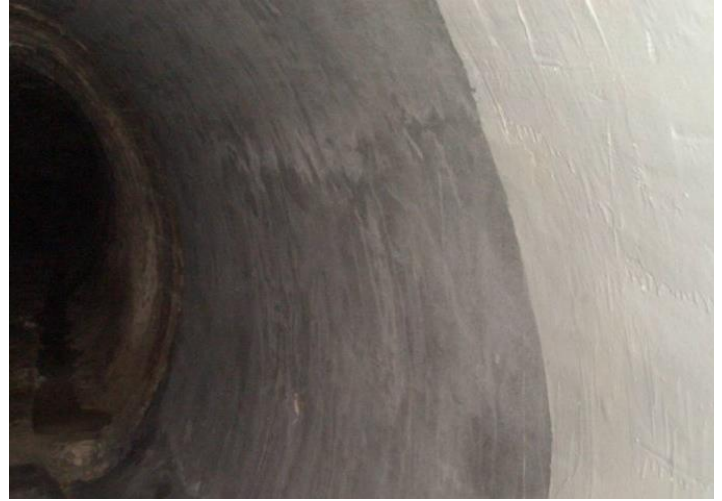
Concrete repair and protective waterproofing work on the gallery

For the repair of damaged concrete MasterEmaco S 5400 was used. Intensive surface preparation was required for the application of the repair mortar, the service was cleaned, and damaged concrete was removed by manual brushing and high-pressure water jetting.

MasterEmaco S 5400 was applied by spraying. Following application, the mortar was troweled to obtain a smooth surface.

After the hardening of the mortar, the two-component water based epoxy coating MasterSeal M338 was applied.
